Mitigating Earthquake Risk
in Health Facilities

A Structural Vulnerability Assessment of Hospitals in Kathmandu Valley

Kathmandu, Nepal
August 2002

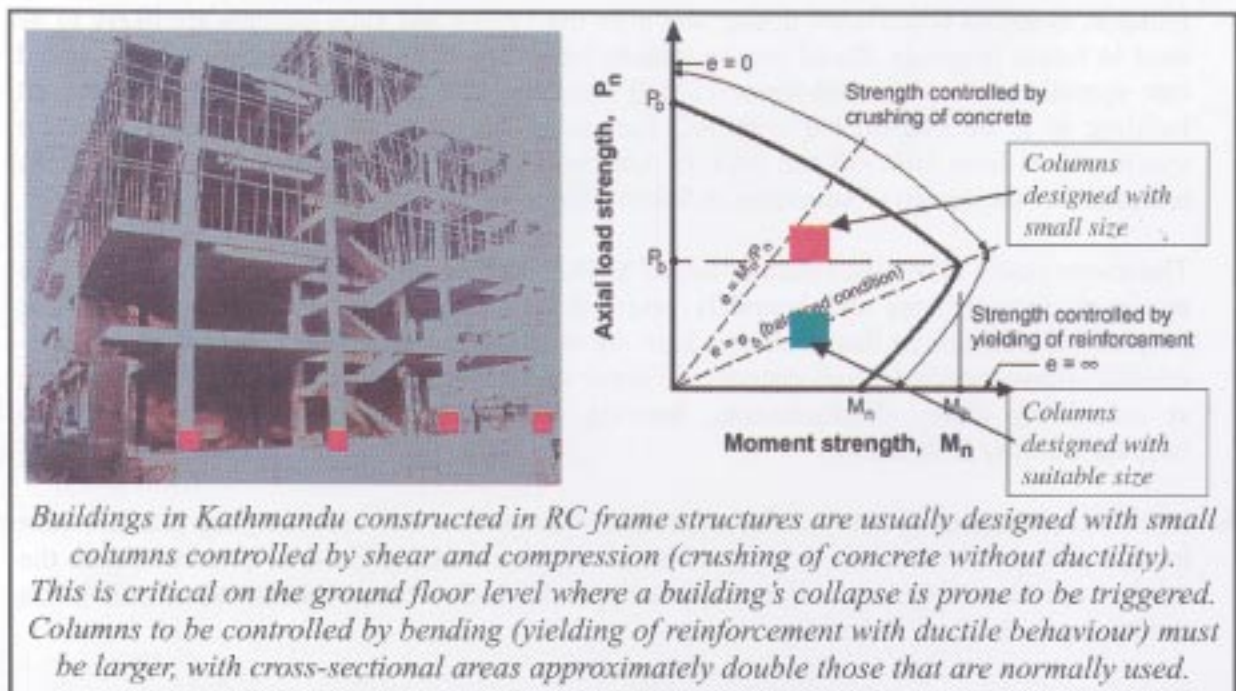
When column size is insufficient, the failure mechanism is fragile, without ductility, and is controlled by compression and shear. Buildings built with small columns will collapse in a "pancake" mode (slab on slab) and the life-safety target is not achieved.

Larger columns than those normally used in Kathmandu need to be designed and constructed. The small size of columns is critical at the ground floor level, where a weak storey can usually be found and a building's collapse is expected to be triggered.

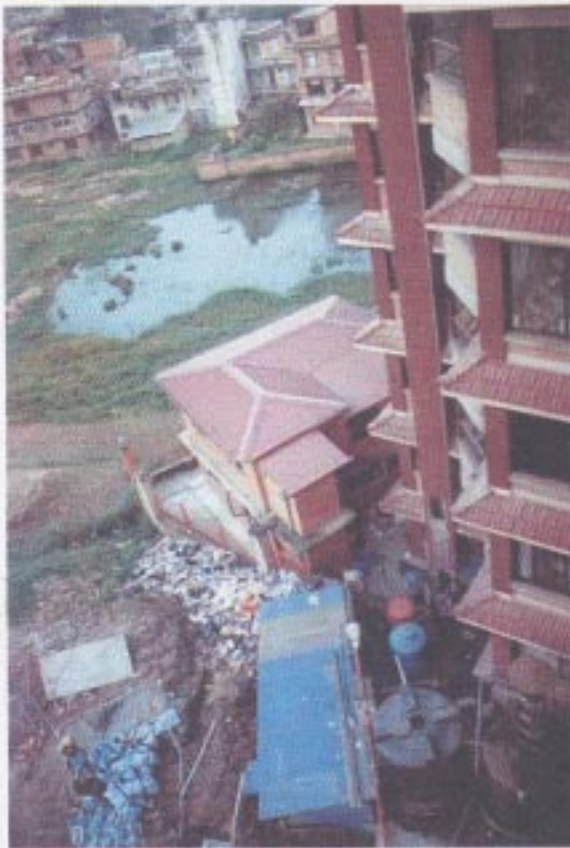
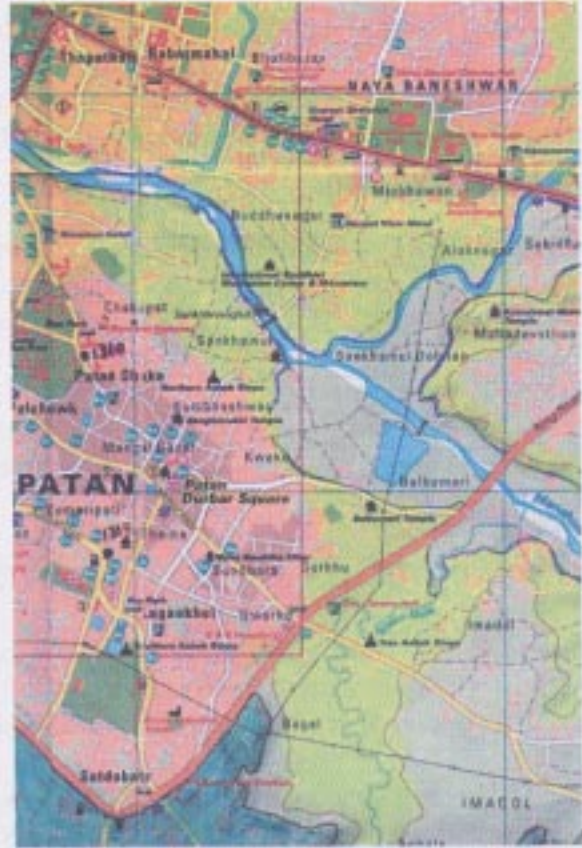
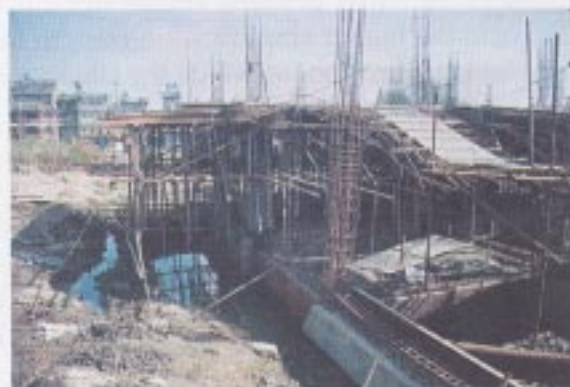
*Drainage problems at Gwarko – Lalitpur.
A pond had formed next to B&B
Hospital as a result of water damming.*

To solve the drainage problem it is recommended that two culverts are placed in the roads referred to above. In this way, the water-table level will be decreased, and the liquefaction potential – if it exists – will be reduced. For the time being, the drainage problem at B&B Hospital is not only a potential source of liquefaction, but also a source of major environmental and sanitary problems.

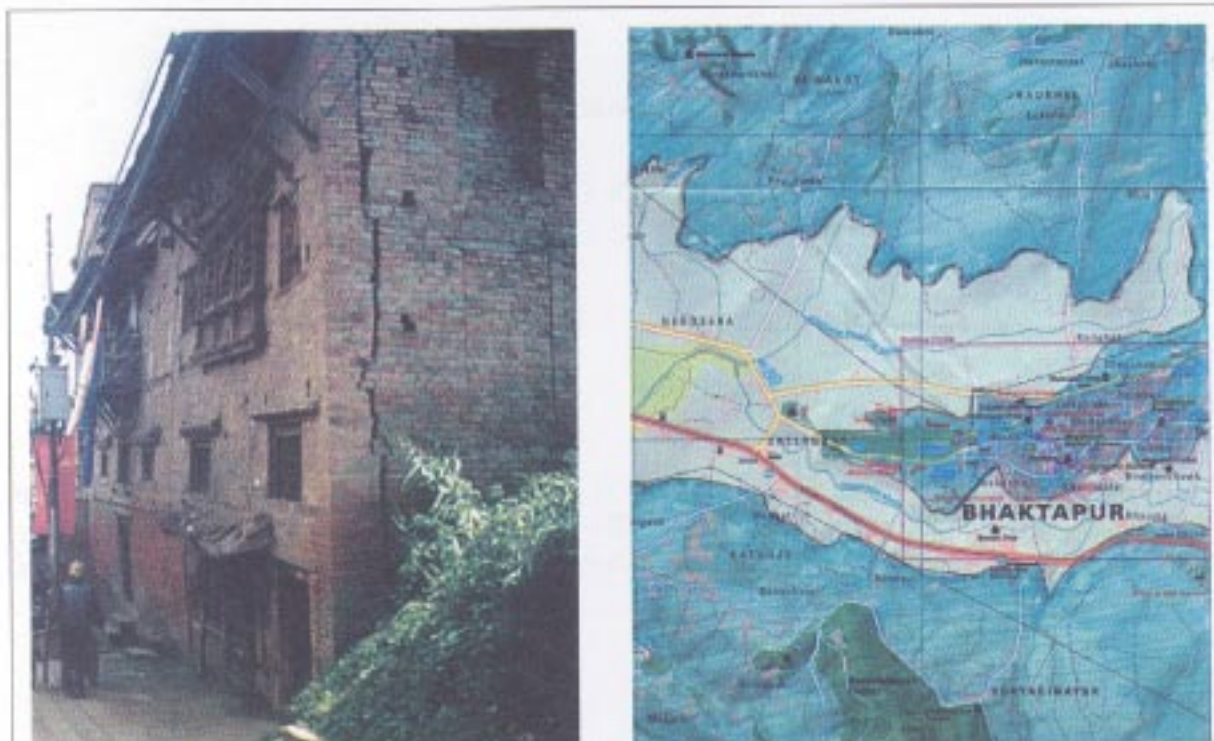
Left: Damage to a building in Bhaktapur city due to previous ground shakings of intensity $MMI = VI$.

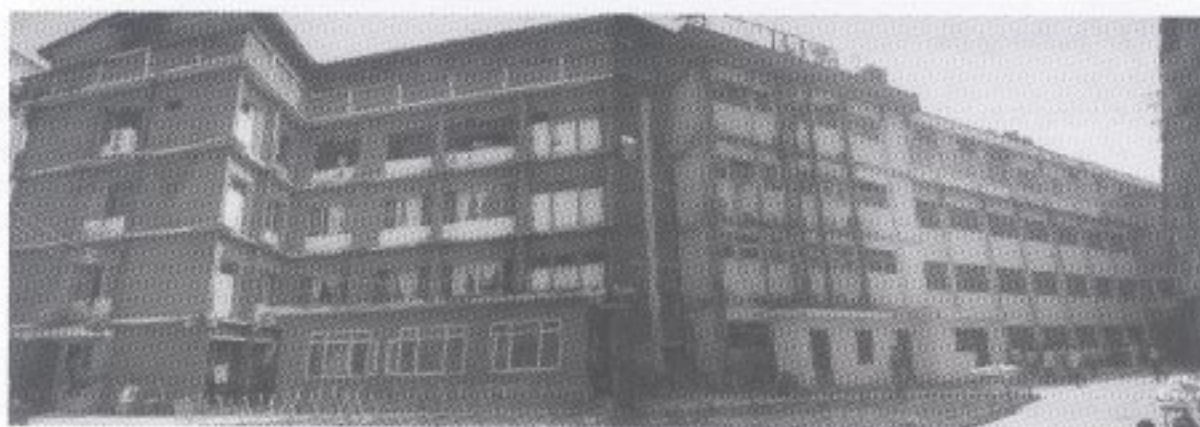
Left building: "L" (intensive care block). **Central building:** The "wedge". **Right building:** One of the "I" building wings (surgical block) connected to a yellow "V" building (VIP block) by a "weak corridor".

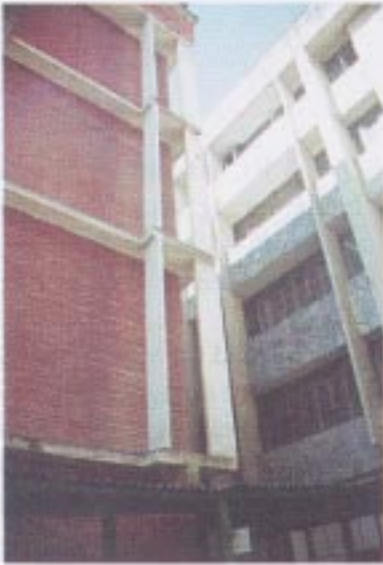
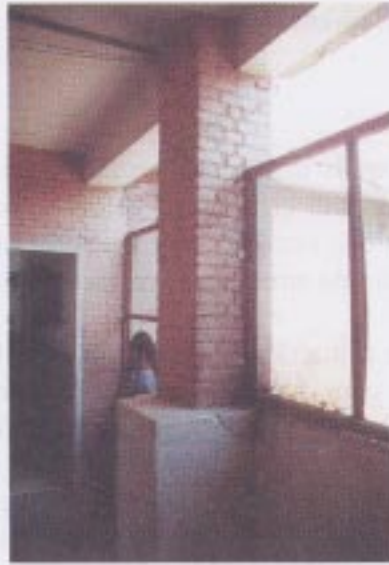
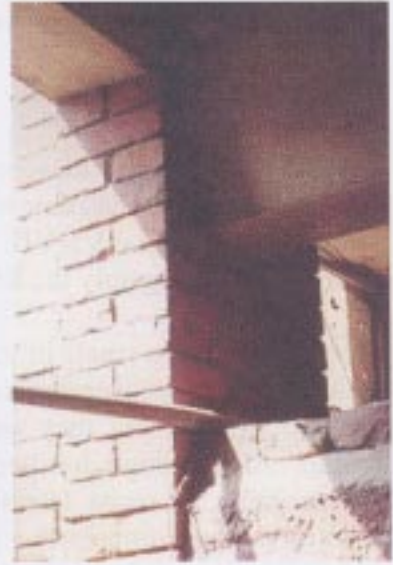
Also, taking into account the other vulnerability factors described in the previous section, this fragile mechanism of collapse is likely to occur during the so-called frequent earthquakes, with small intensity ($\text{MMI} = \text{VII}$) and peak ground acceleration of from 0.1 g to 0.2 g.

"L" building: Left: Masonry or RC blocks can fall down and injure people during a MMI = VI-VII earthquake. Middle and Right: Short columns will be able to trigger the building and lead to fragile-collapsing-mechanism (pancake failure) during a MMI = VII earthquake.

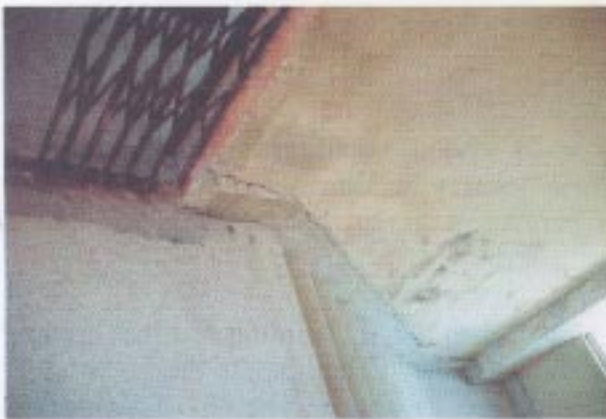
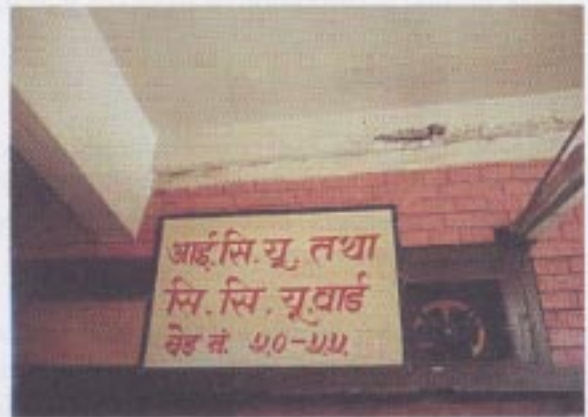
*Cracks in pounding area between the "wedge" and the "L" building.
Left: Top storey. Right: First storey.*

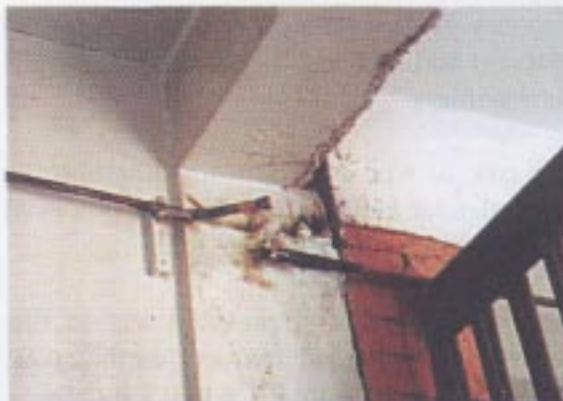
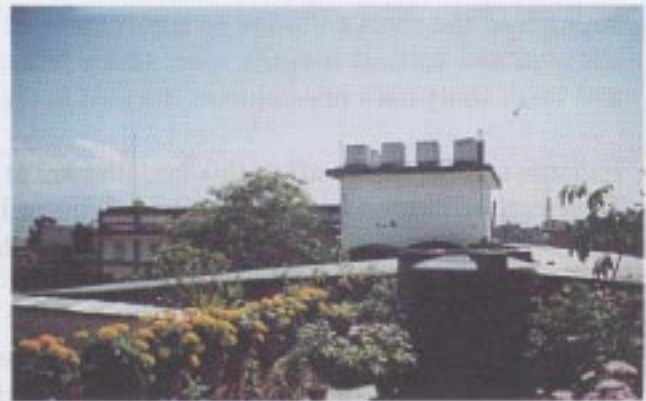
*Left: Broken oxygen pipeline at pounding area of "L" building and the "wedge".
Right: View from the "wedge".*

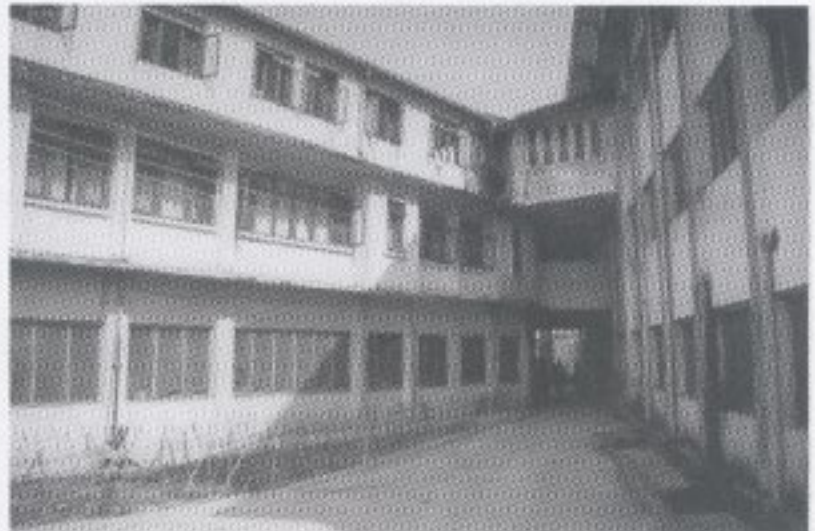
Left: Deterioration of concrete and steel corrosion in "I" building's roof due to dampness. **Right:** "V" and "I" buildings connected by a "weak corridor"

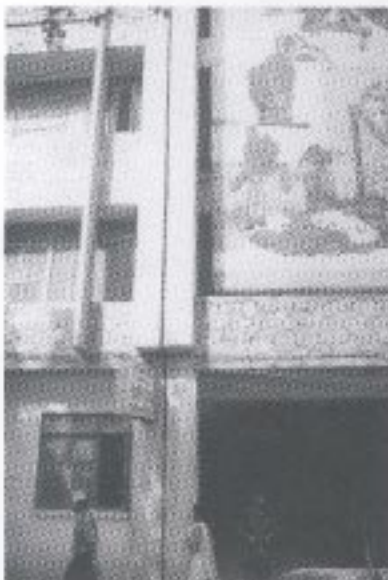
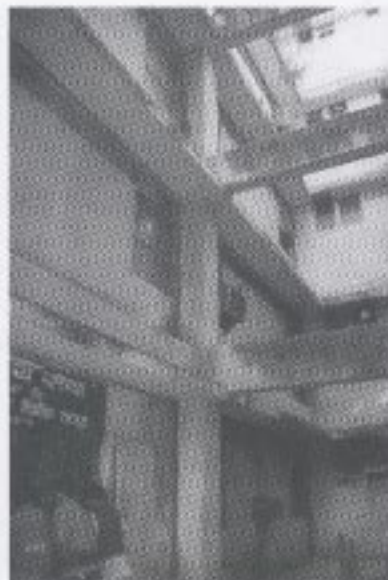
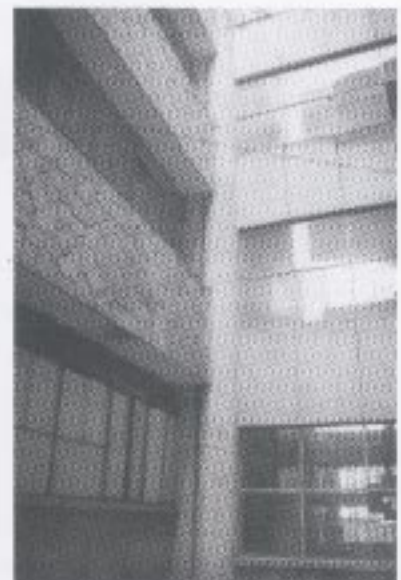
"New" buildings. Left: Seismic joint of small size in the main building facing Kanti Path. **Middle:** Diaphragm discontinuity in one of the three structures composing the main new building. **Right:** Masonry parapets rigidly connect the new buildings where a seismic joint was designed.

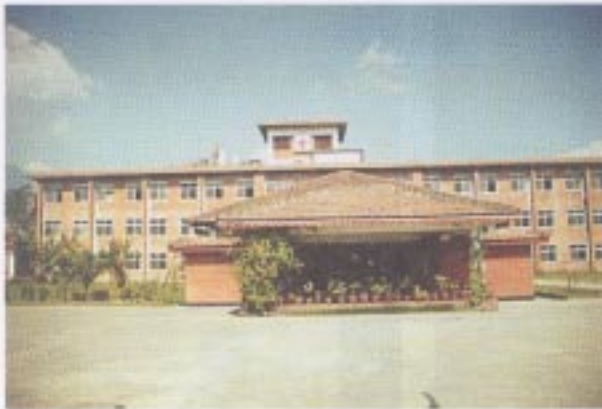
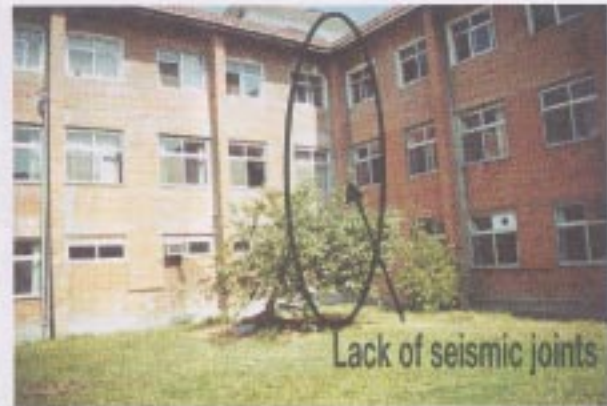
Left: Army Hospital main entrance. **Right:** One of the many re-entrant corners in the hospital. Decorative bricks cover the columns in the outer frames.

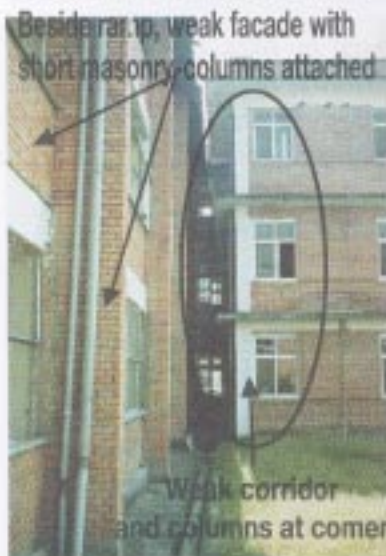
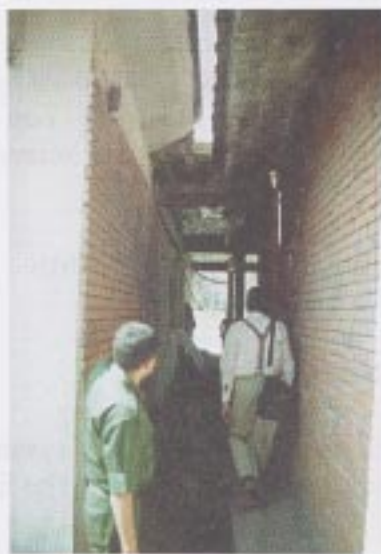
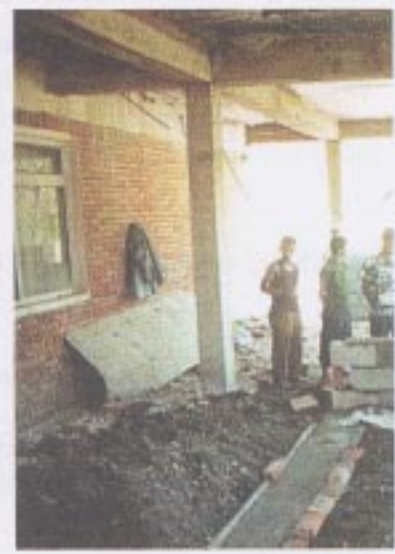
Left: Two blocks are rigidly connected with a weak corridor, which is likely to be crushed by strong ground shaking. The block on the right side is the out-patients, physiotherapy, and medical trainee centre block that has outer columns of 35 x 35 cm in size.

Centre and Right: A new one-storey block is under construction without seismic joints. The lack of joints and the plan irregularities can produce moderate to heavy structural damages in columns at outer and re-entrant corners during intensity MMI = IX.

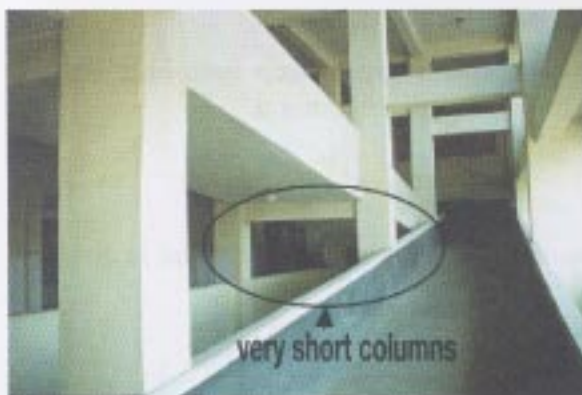
Indoors, there is a rigid inclined ramp defining short columns. Other central columns not bearing the ramp are considered to have enough seismic capacity according to their size.

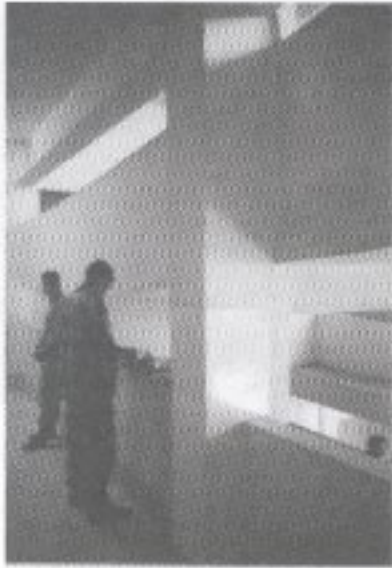
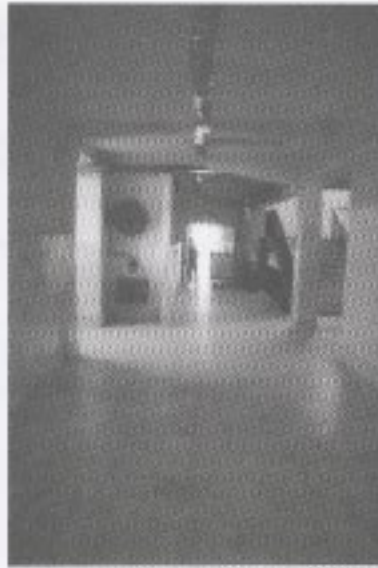
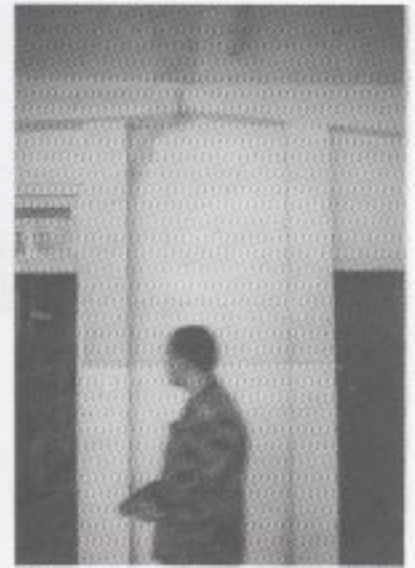
Left: Short column in the ramp area. Centre: Seismic joints closed by tiles, cement mortar, and a seal to avoid water leaks. Right: Seismic joint closed by masonry, and a repaired crack – probably caused by a previous small ground shaking – can be seen. In areas where seismic joints are closed, earthquakes usually produce the most severe damage.

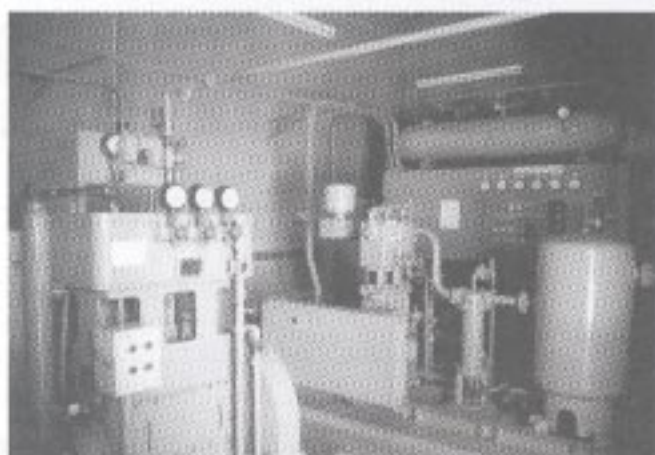
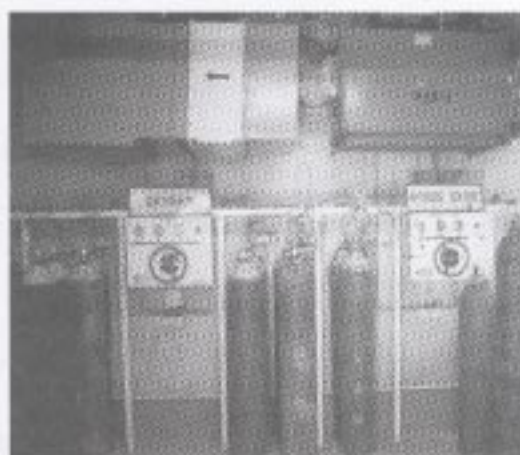
Central oxygen room. Left: Oxygen plant. Maintenance is very good for local standards. Right: Oxygen cylinders being refilled. The lateral stability of such cylinders should be improved by using devices designed to fit the cylinders to the ground while they are refilled.

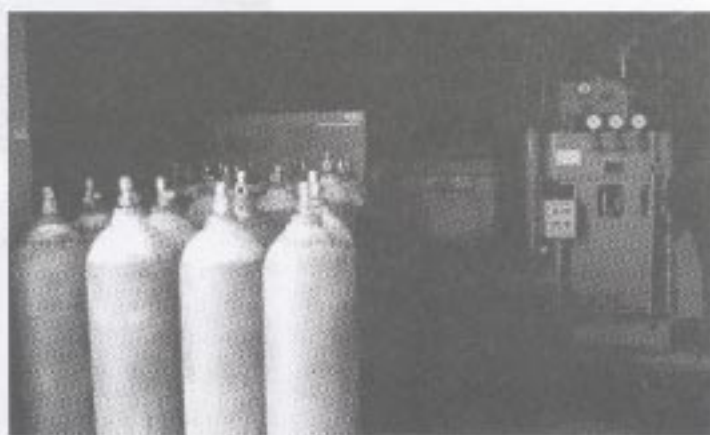
Left: Oxygen cylinders in a storage area. Right: Oxygen cylinders in the central oxygen room. To reduce non-structural vulnerability it is necessary to keep slender equipment, harmful to people, well-fitted and restrained against overturning.

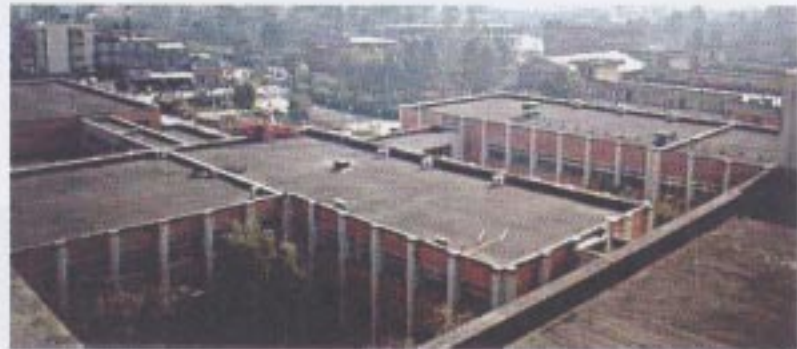
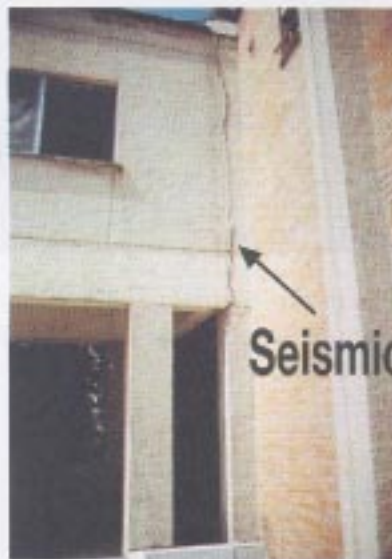
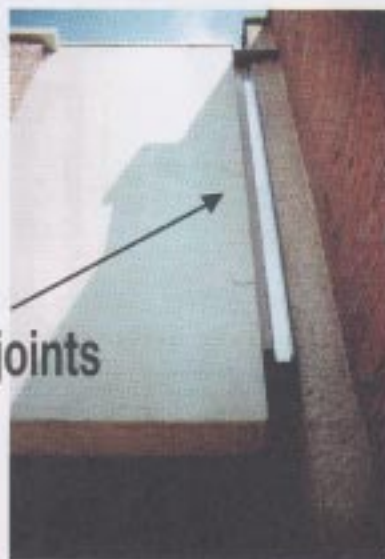
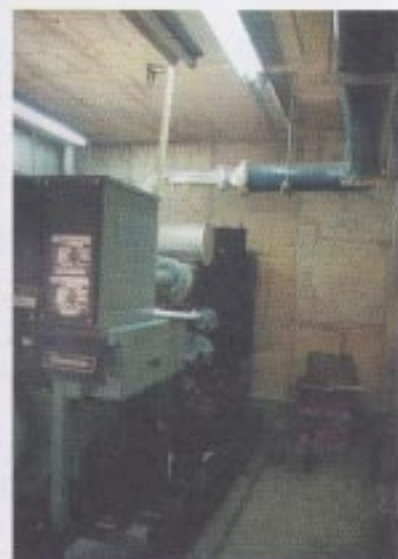
Seismic joints are not totally open. The buildings can dynamically interact and pound during earthquakes. This may cause slight to moderate damage to non-structural components during high intensity earthquakes (MMI = IX).

Left: A seismic joint between block B and a weak corridor connecting it with block C. Mortar plastering has already cracked due to previous ground shakings.

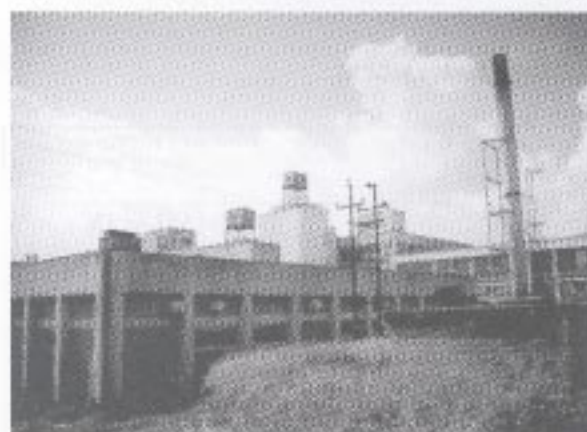
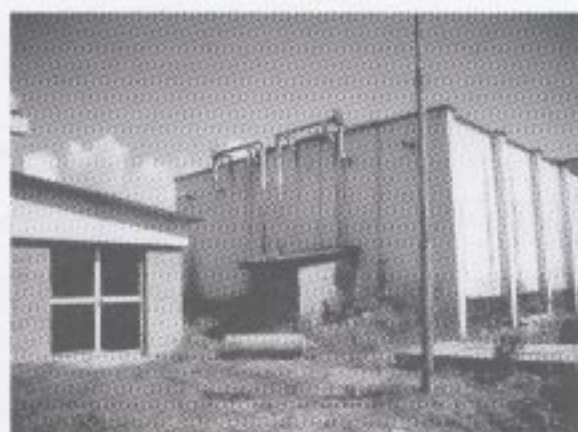
Left: Water tanks (12 cubic-metres in capacity) on the roofs of buildings. The stability of such structures under intensity $MMI = VIII-IX$ earthquakes need to be assessed.

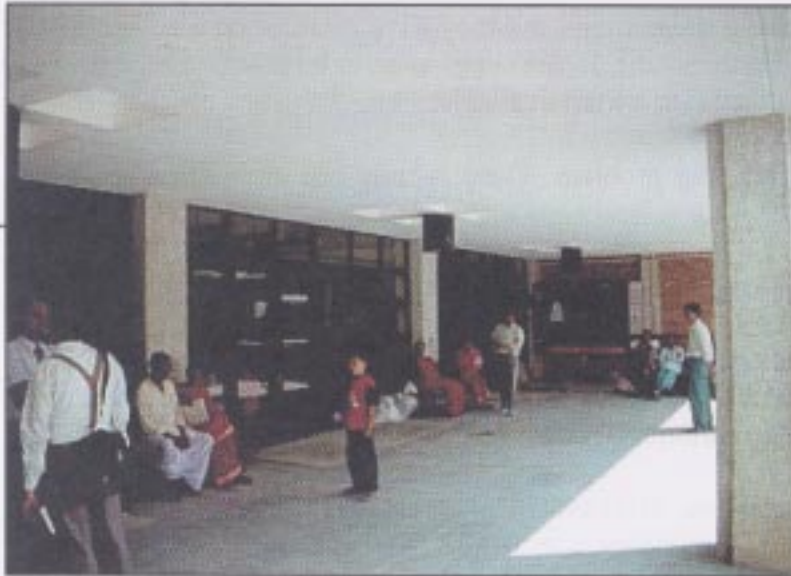
Entrance Hall of block A, next to the emergency department room.

It is also recommend that the stability of the glass wall located in this area is increased.

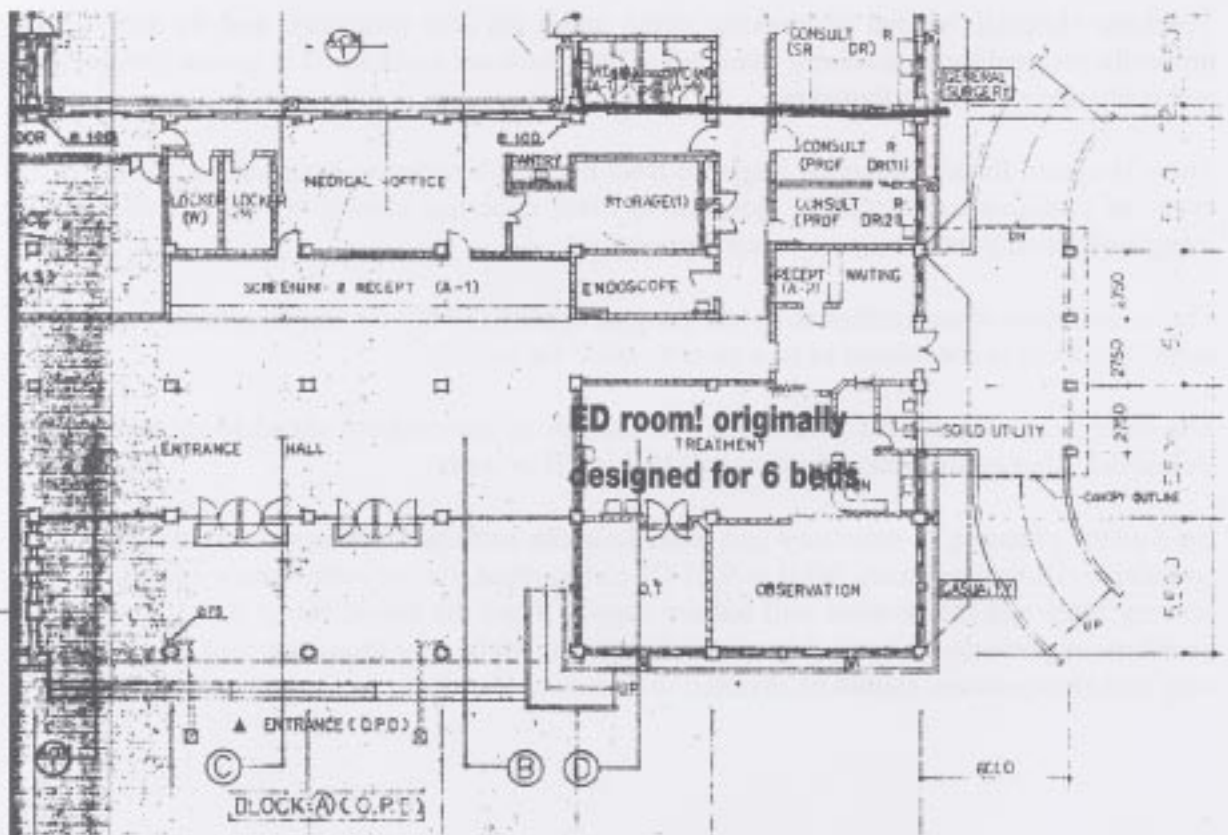
Originally designed to accommodate 6 beds, the emergency department room now has 16. Its current capacity is permanently exceeded. It is necessary to enlarge this room to a capacity of at least 35 observation beds.

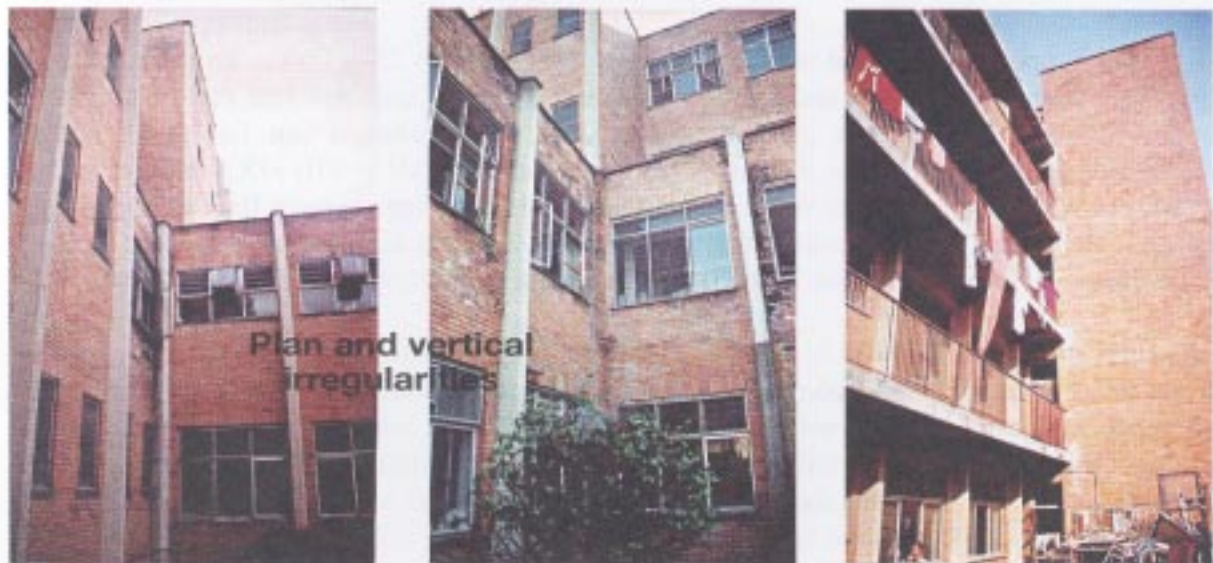
Left and Centre: Outer and re-entrant corners, and a closed seismic joint between the main 4-storey building and the surgical block, which is a 2-storey building. The vertical and plan irregularities due to the building setback in elevation and irregular plan shape can also be seen. **Right:** Reinforced concrete wall covered by a masonry wall with decorative bricks that are not well connected to the RC wall and can easily fall down during an earthquake of intensity MMI = VII or above. The RC wall of the main staircase is attached to the main building's floor slabs, and is not well connected to its moment-resistant-frame-structure.
