SEISMIC VULNERABILITY OF THE PUBLIC SCHOOL BUILDINGS OF KATHMANDU VALLEY AND METHODS FOR REDUCING IT

KATHMANDU VALLEY SCHOOL EARTHQUAKE SAFETY PROGRAM (SES)

THE KATHMANDU VALLEY EARTHQUAKE RISK MANAGEMENT PROJECT (KVERMP)

August 2000, Kathmandu, Nepal

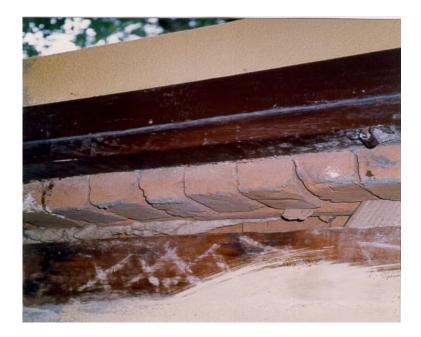
The most common lintel material is timber (generally locally available softwood) and reinforced concrete. In many schools crumbling of walling materials has been observed due to decay of timber lintel leading building in hazardous condition.

Photograph 4.2: Timber lintel in masonry building. [NSET-Nepal's Archive]

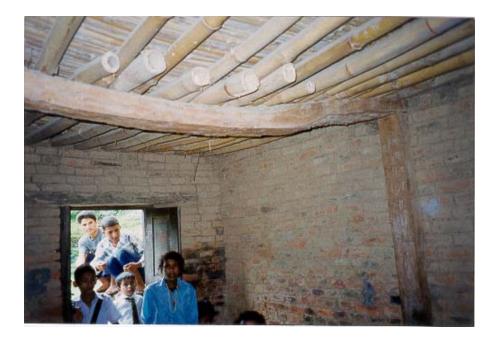
Photograph 4.4: Flexible floor construction of earth laid on bamboo, timber structure. Note the sagging the timber beam. [NSET-Nepal's Archive]

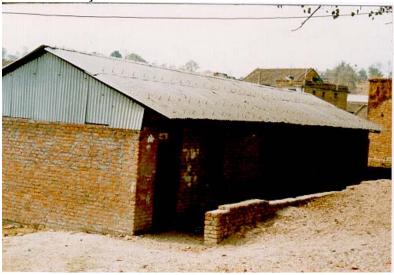
The project, considering out of plane failure of heavy gable walls, supplied CGI sheet for gable. But 27.6% buildings do have replaced CGI sheet with heavy cladding walls, thereby increasing the risk. Table 4.9 presents use of different materials for gable wall. Photograph 4.9 (Appendix-9) presents originally proposed CGI sheet gable wall and masonry gable wall.

Photograph 4. 9: Gable walls are constructed of CGI sheet in *earthquake block*. Note the free standing masonry walls and omission of sill level band (though existed in design). [NSET-Nepal's Archive]

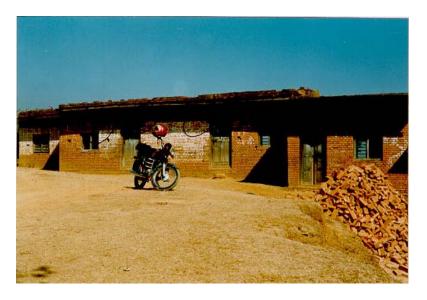
Photograph 4.10: No lintels at all over openings. [NSET-Nepal's Archive]

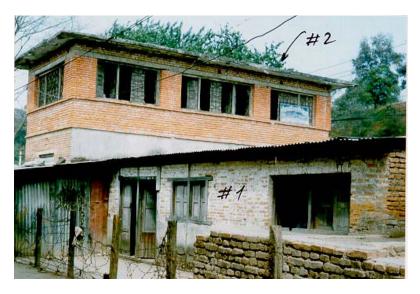
Photograph 4.11: Lintel band in 2nd story but the same is ignored in 1st story. [NSET-Nepal's Archive]

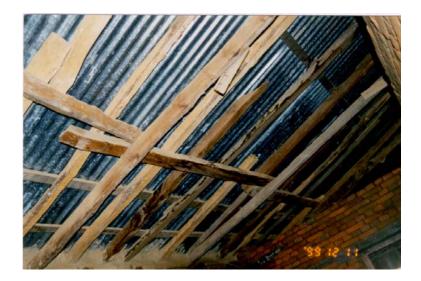
Photograph 4.12: Loose fit timber roof structure. [NSET-Nepal's Archive]

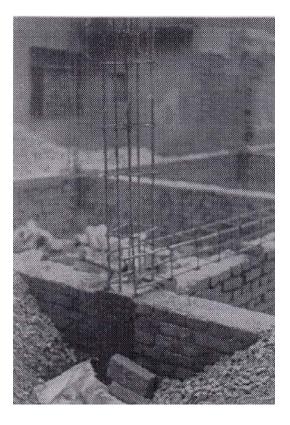
Photograph 4.13: Shape and spacing of stirrups in a column and beam. Also note beam bar anchorage in column. [Courtesy: Jitendra K. Bothara]

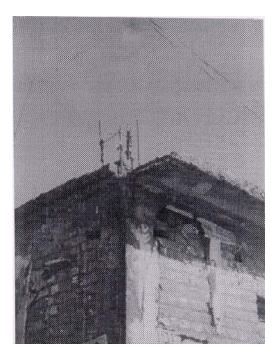
Photograph 4.14: Available lap length for splicing. [Courtesy: Jitendra K. Bothara]

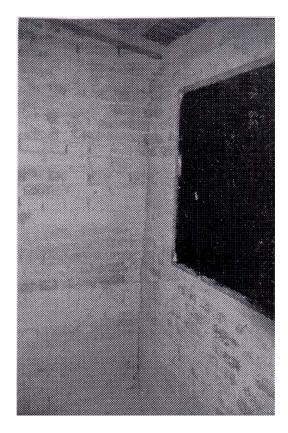
Photograph 4.15:

No connection between two orthogonal walls made of brick in cement mortar. [NSET-Nepal's Archive]

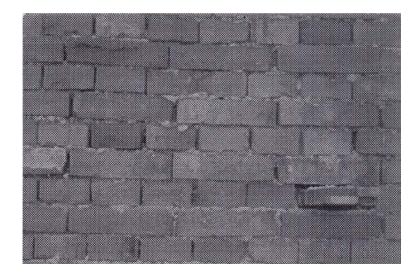
Photograph 4.16: No mortar between walling units. [Courtesy: Jitendra K. Bothara]

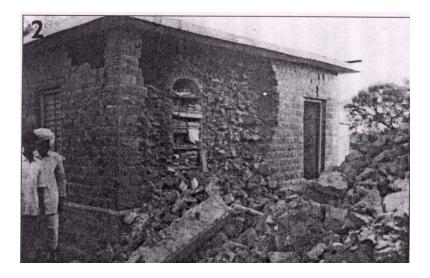
Photograph 4.17: Delamination of structural walls due to absence of 'through' stone. [NSET-Nepal's Archive]
