Mitigating Earthquake Risk
in Health Facilities

A Structural Vulnerability Assessment of Hospitals in Kathmandu Valley

Kathmandu, Nepal
August 2002

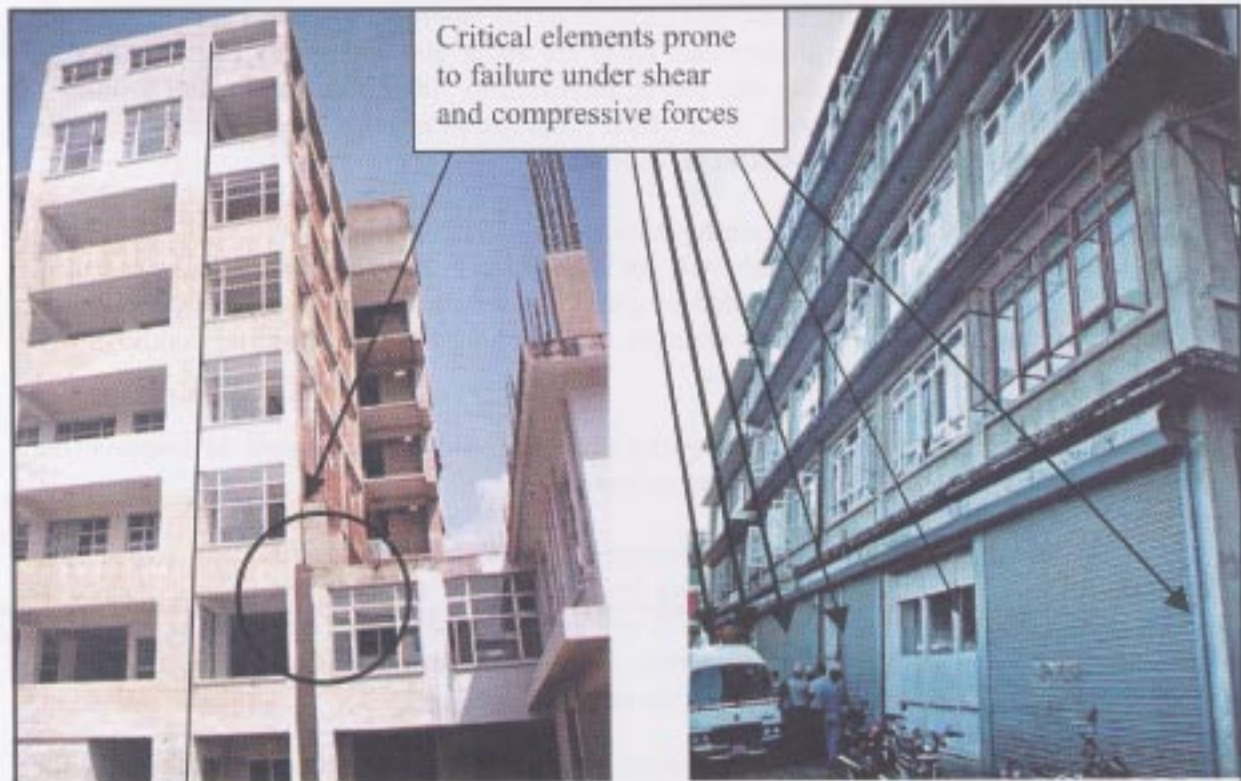
Critical elements prone
to failure under shear
and compressive forces

Left: Nepal Medical College at Aterkhel. An 8-storey building that is under construction. Columns are 45 x 45 cm throughout the building. 70 x 70 cm columns are required on the ground floor. **Right:** Model Hospital's surgery block at Baghbazar. A 5-storey building with 23 x 23 cm columns. On the ground floor 50 x 50 cm columns are required. Private hospitals are usually designed like ordinary buildings using RC structures.

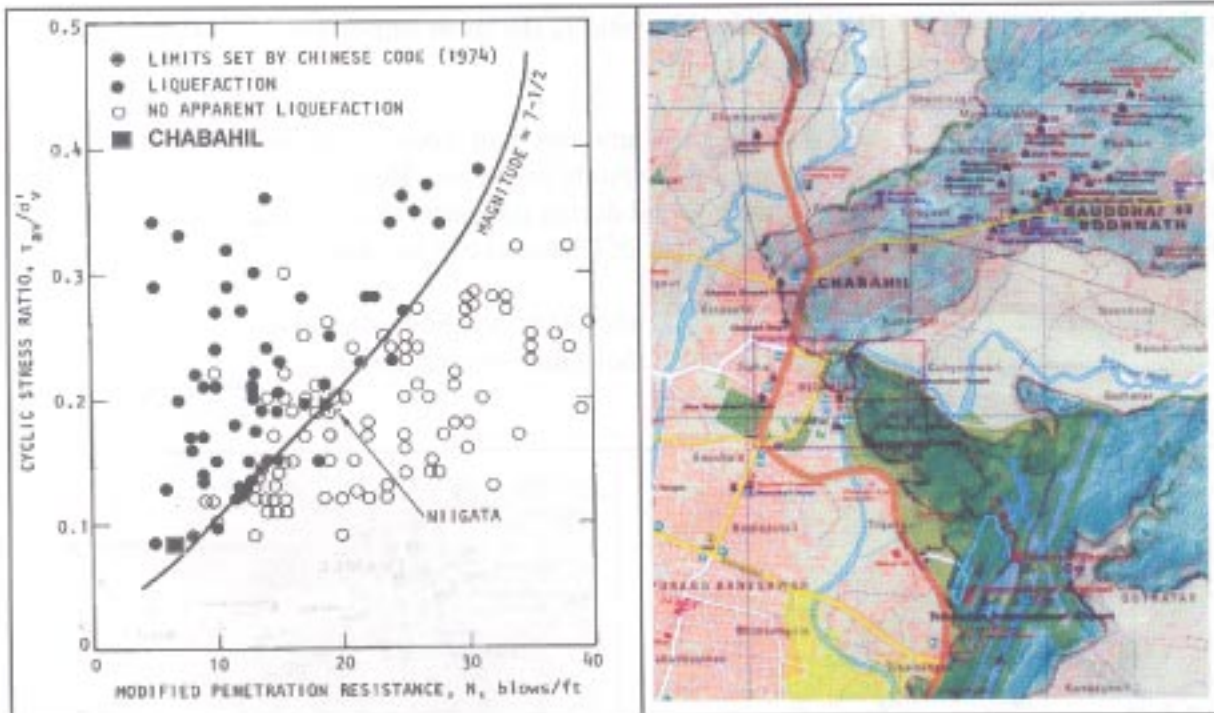
At the site, a sandy layer (SP) was found from the ground surface to a depth of 5-6 metres, having a modified penetration resistance $N_1 = 7$. The liquefaction analysis was carried out assuming that liquefaction will occur at a depth of 3 metres, where soil can be presumed to be saturated. The liquefaction potential was found to be very high - the sandy layer may liquefy in an earthquake of intensity $MMI = VII$ or above.

Soil liquefaction analysis at Chabahil.
For peak ground acceleration = 0.1 g (MMI = VII).

However, a detailed evaluation of the hydrostatic water-table level using piezometers is recommended. If the piezometric head is found to be below 6 metres in depth, the liquefaction potential will be significantly reduced.

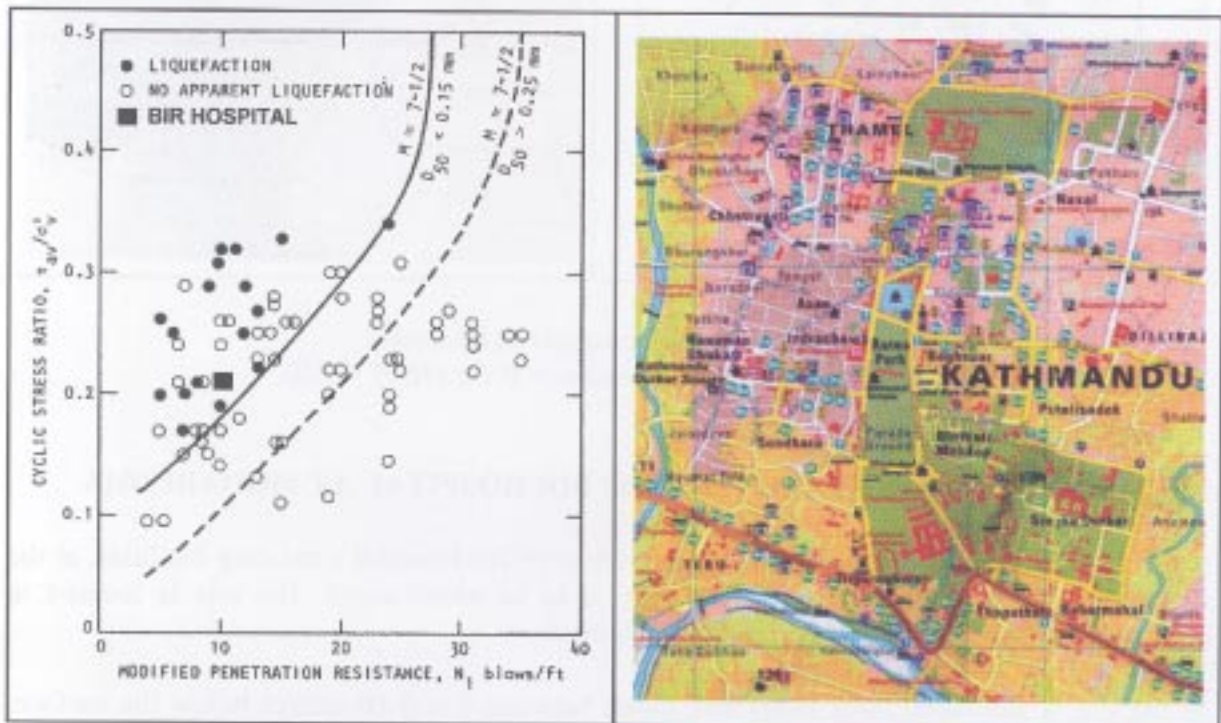
Soil liquefaction analysis of Bir Hospital at Mohaboudha.
For peak ground acceleration = 0.35 g (MMI = IX).

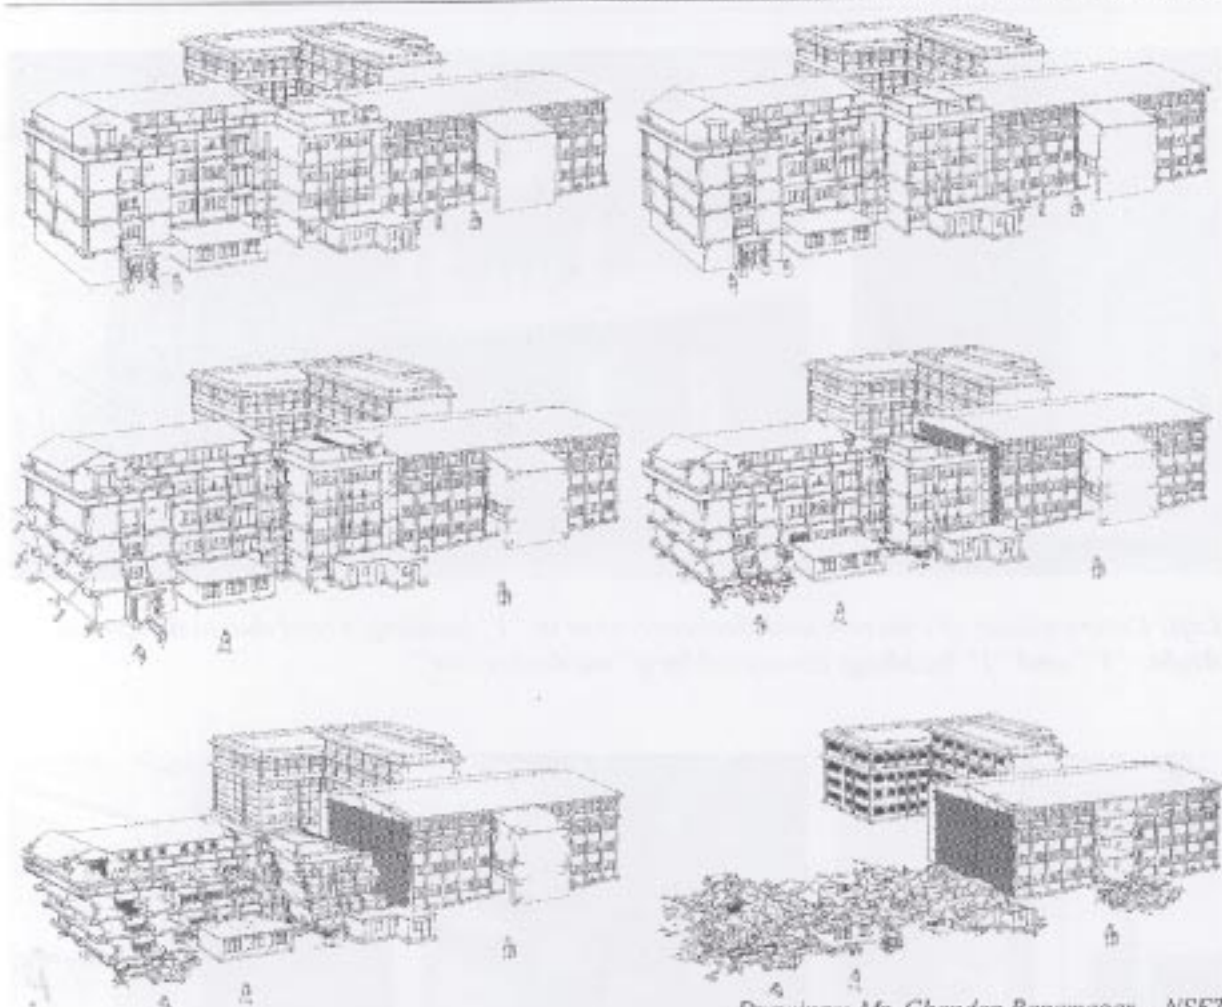
*Probable pattern of collapse to "L" building, or intensive care unit,
during a MMI = VII earthquake.*

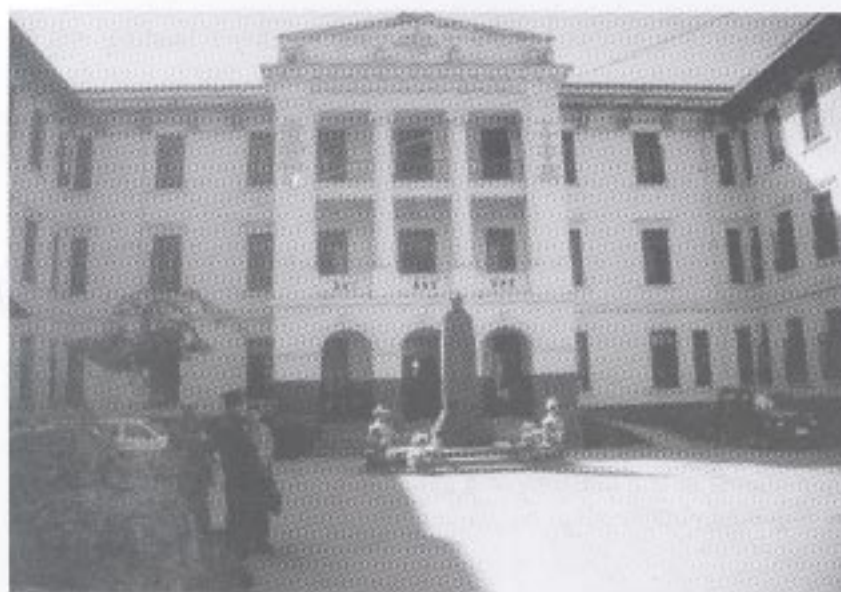
The Old Military Hospital building, which is considered to be able to withstand up to intensity $MMI = IX$ earthquakes.

It is of low structural vulnerability because of its thick walls (70 - 80 cm).

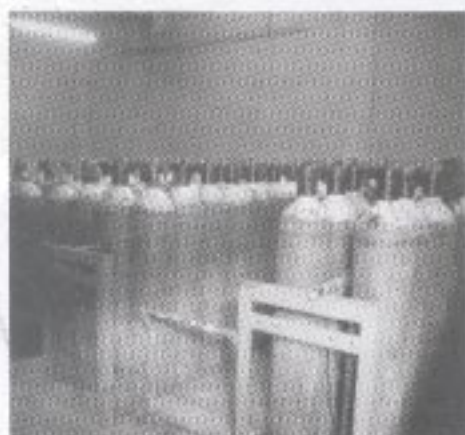
Left: Oxygen cylinders in a storage area. Right: Oxygen cylinders in the central oxygen room. To reduce non-structural vulnerability it is necessary to keep slender equipment, harmful to people, well-fitted and restrained against overturning.

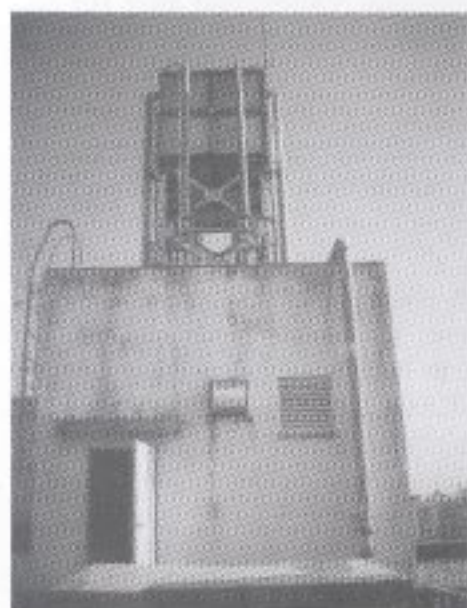
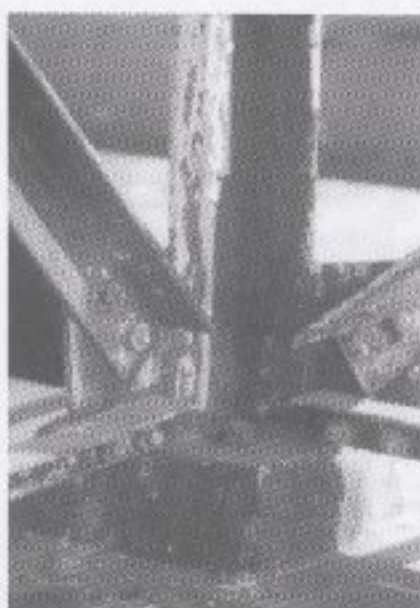
Left: A 12 cubic-metre water tank on the roof of a 4-storey block.

Right: The strength capacity of water tank restraints should be checked.

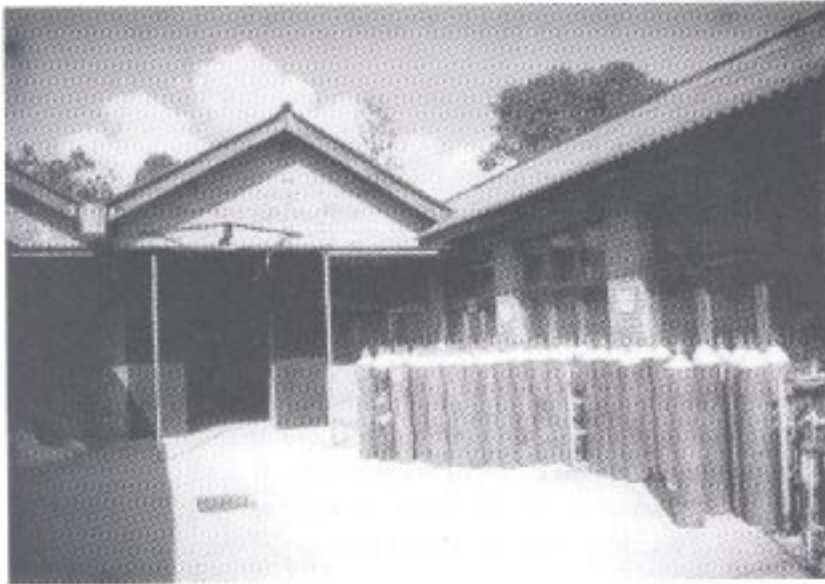
The oxygen room stores 10 cylinders. Most of the cylinders are stored outside, some are full and others empty, waiting for replacement from outside the hospital. These cylinders are not restrained to prevent overturning. The hospital is planning to build a central room for oxygen to cope with the hospital's requirements, but the location has not yet been decided and there are financial problems related to this construction.

Oxygen cylinders storage area.

To reduce non-structural vulnerability it is necessary to keep all of the slender equipment which can be harmful to people well-fitted and restrained against overturning.

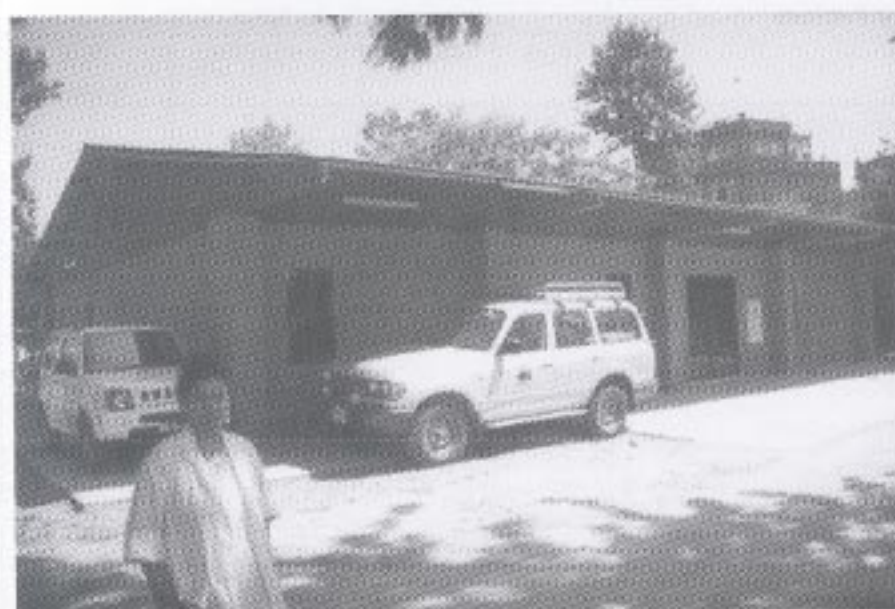
The emergency block. An earthquake resistant building with 7 observation beds. This is a new facility constructed in 2001.

It is not operating yet, because of a lack of furniture, medical equipment and electricity supply. It is of high priority to make it operational.

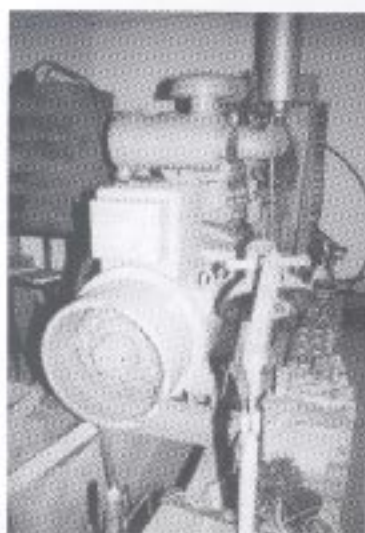
Left: Manually operated emergency-backup electricity generator.

- a) Vertical and plan irregularities can produce moderate to heavy non-structural damage in lifeline facilities during moderate to high intensity earthquakes (MMI = VIII-IX).
- b) The buildings have very simple lifeline systems so during small earthquakes (MMI = VII) slight to moderate non-structural damage can be expected, but the hospital is likely to be able to function under such conditions.
- c) The hospital is highly dependent upon city network facilities such as electricity, water and telephones, but utilities from the city network will probably not be available for days or weeks after moderate to high intensity earthquakes (MMI = VIII-IX). They are not considered sufficiently reliable under intensity MMI = VII earthquakes either.
- d) The electricity generator backup is manually operated, and only one person is in charge and trained to operate it.

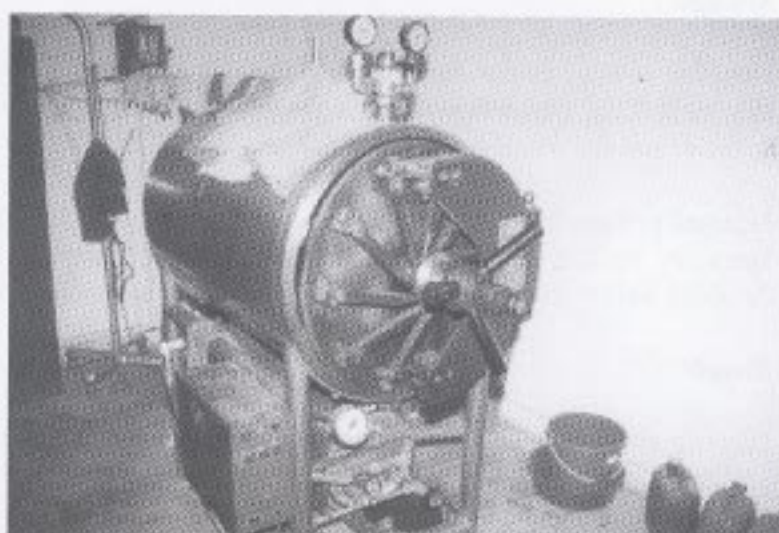
Right: Main autoclave at the central sterilisation supply department (CSSD). In the event of a shortage of electricity from the city network, the autoclaves at CSSD will not be functioning. The backup generator can only supply electricity to operating theatres and the emergency department.

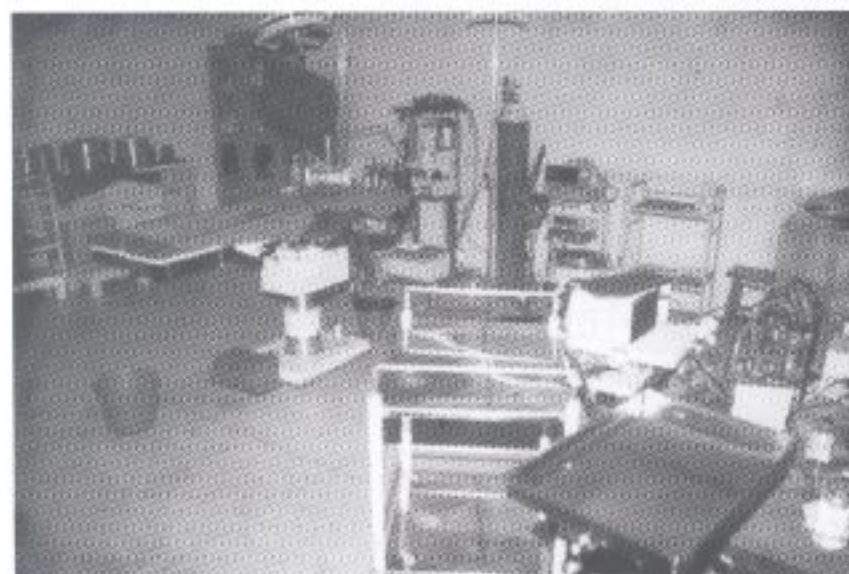
Main operating theatre. Less than 8 minor and major surgeries are conducted in the hospital per day. There is no intensive care unit.

An undesirable contrast: low demand from the community during most of the year, while a very big demand is expected during earthquake emergencies.

It is also recommended that the medical care services are strengthened by building a new 120 bed hospital equipped with an emergency department, operating theatres and an intensive care unit. Such a hospital should be developed under a community based system.
