SEISMIC VULNERABILITY OF THE PUBLIC SCHOOL BUILDINGS OF KATHMANDU VALLEY AND METHODS FOR REDUCING IT

KATHMANDU VALLEY SCHOOL EARTHQUAKE SAFETY PROGRAM (SES)

THE KATHMANDU VALLEY EARTHQUAKE RISK MANAGEMENT PROJECT (KVERMP)

August 2000, Kathmandu, Nepal

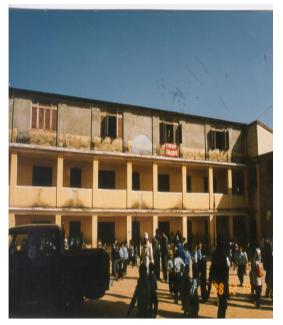
A three- story masonry building in brick in cement mortar with flexible roof.

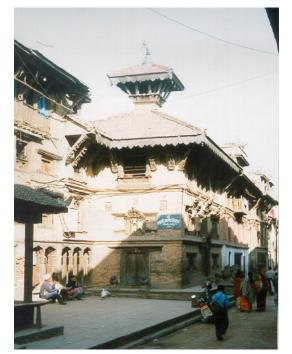
A school building in dense urban area. Clay tile roof and Timber floor resting on fired brick in cement mortar (constd. By Bhaktapur Development Project)

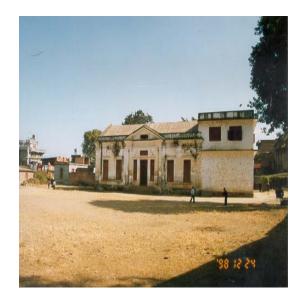
A Rana Era Victorian style one story school building. Walls brick in lime, CGI sheet roof on timber structure (Constd. Befor e 2000 B.S.)

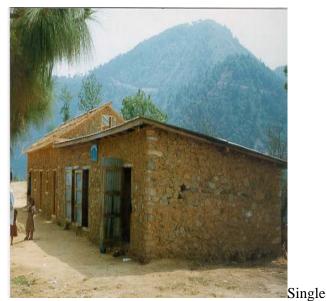
pitched CGI sheet roof on stone walls is mud mortar.

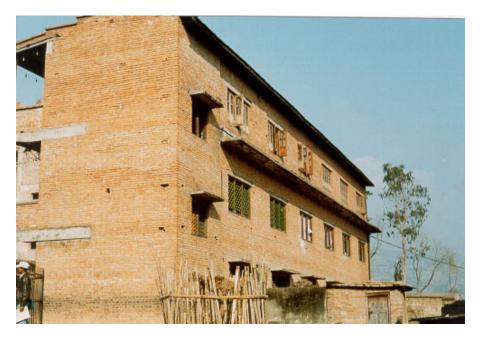
Photographs 4.2 and 4.3 (Appendix-9) presents lintels construction using timber and concrete respectively.

Photograph 4.3: RC lintel in masonry building. [NSET-Nepal's Archive]

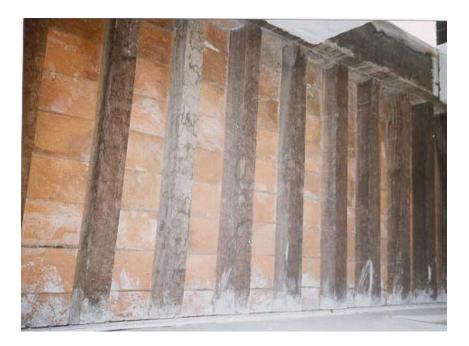
Photographs 4.4, 4.5, and 4.6 (Appendix-9) depict the use of bamboo, timber and brick in floor construction.

Photograph 4.5: Floor constructed of plain concrete laid over brick supported by timber joist. [NSET-Nepal's Archive]

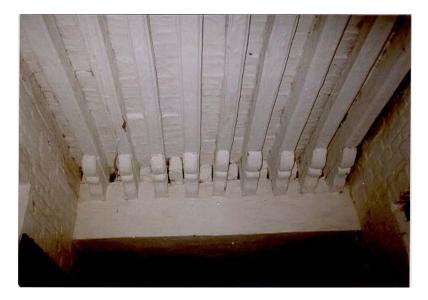
Photograph 4.6: Floor constructed with earth laid on brick supported by timber joist. [NSET-Nepal's Archive]

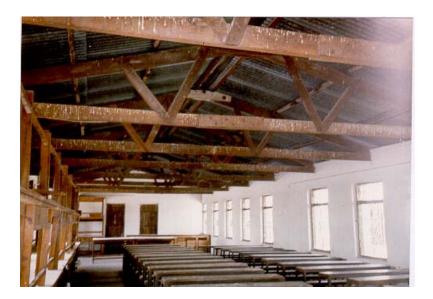
Photographs 4.7, and 4.8 (Appendix-9) depict the use of timber, steel, CGI sheet, and jhingati (clay tiles) for roof construction.

Photograph 4.7: CGI sheet laid over Timber truss. [NSET-Nepal's Archive]

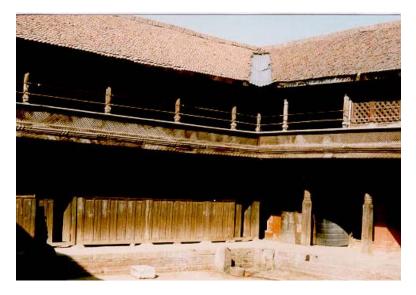
Photograph 4.8: Jhingati (clay roofing tiles) laid over timber structure. [NSET-Nepal's Archive]

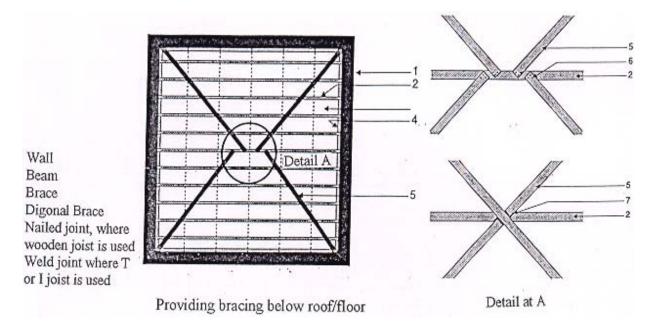
Figure 5.3: Stiffening flexible floor by bracing [1].

Integrity between different elements of timber floor structured, lack of anchorage between floor joists and wall and lack of diaphragm action are general problems with timber floor. The anchorage between different timber elements can be improved by nailing/ strapping. Anchorage between floor joists can be improved by nailing steel straps to joists and anchoring them in wall. The diaphragm action can be achieved by laying a thin reinforced concrete topping over timber floor or bracing the timber floor as shown in Figure 5.2 and 5.3 (Appendix-10) shows floor topping and bracing respectively.

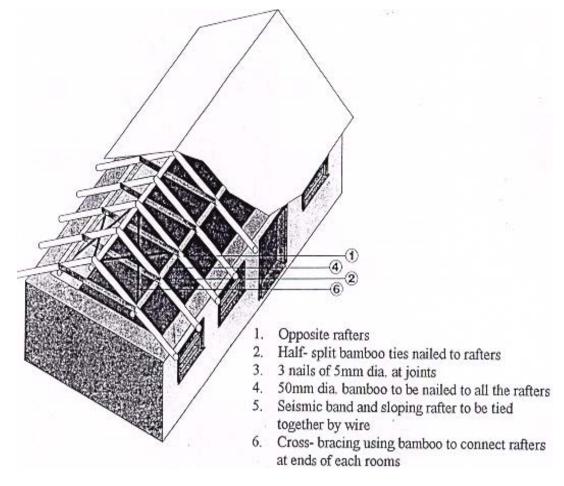
Figure 5.4: Roof bracing [1].

The problems identified for floor is also applicable to timber roof structure. Integrity between different elements of roof, and rafters and wall can be improved by nailing and/ or strapping (Ref. Photograph 5.1, Appendix-9). Diaphragm action can be achieved by roof bracing. Figure 5.4 (Appendix-10) shows scheme for roof bracing.

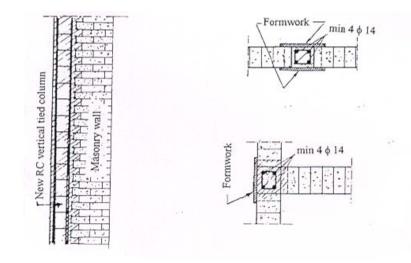
Figure 5.5: Masonry strengthened by introduction of column [9].

In this scheme, reinforced concrete columns are added at ends of cross and longitudinal walls and horizontal reinforced concrete beams are added monolithic to the added columns. Crossties are used to connect opposite columns. Photograph 5.3 (Appendix-9) presents a general view of strengthening by RC column and beam scheme. Figure 5.5 (Appendix-10) shows a general scheme for use of reinforced column.

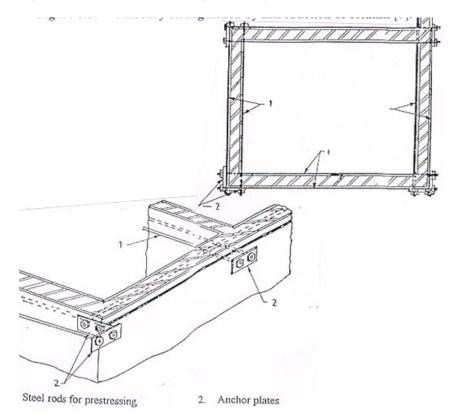
Figure 5.6: Retrofitting masonry building by prestressing [9].

A horizontal compression state induced by horizontal tendons can be used to increase the shear strength of walls. Moreover this will also improve considerably the connection of orthogonal walls. Figure 5.6 (Appendix-10) shows a general scheme for prestressing.

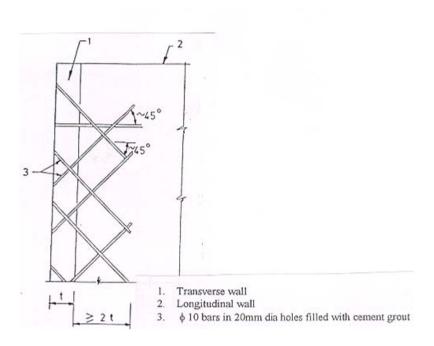
Figure 5.7: Stitching of transverse walls with inclined bars [3].

The weak connection between orthogonal walls at corners, T-junctions can be improved by stitching these walls with steel bars. The stitching can be done by drilling walls first, filling the drill hole with cement grout and forcefully inserting steel bar. Figure 5.7 (Appendix-10) shows stitching of walls.

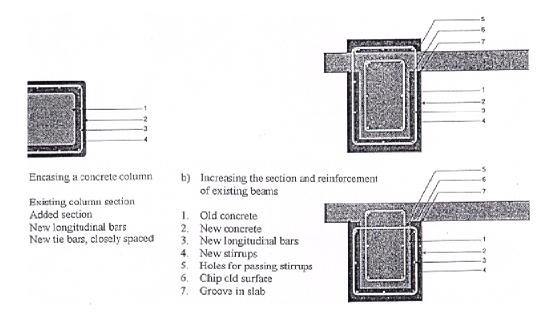
Figure 5.10: RC jacketing of RC beam and column [1].

Building frame with inadequate strength and ductility can be strengthened by casting, that is, by providing additional cage of longitudinal and lateral tie reinforcement around the column and beam and casting a concrete jacket as shown in figure 5.10 (Appendix-10). The sections can also be used for the purpose as shown in Figure 5.11 (Appendix-10).

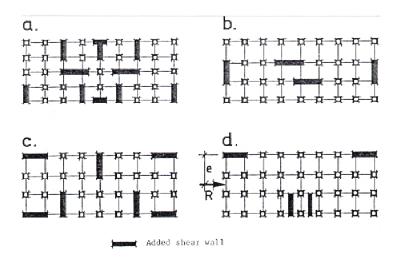
Fig 5.12: RC building retrofitted by introduction of sh ear walls [9].

Building frame having enough strength for normal load (i.e. dead load and imposed load) but lacking strength and ductility for lateral load can be strengthened by infilling appropriate bays by in-situ reinforced concrete shear walls with proper anchorage to the existing frame. In this case, the shear walls can be designed to carry the entire lateral load. New foundations will be required for these shear walls. Figure 5.12 (Appendix-10) presents a scheme for introduction of shear wall.

This solutions seems more promising as it will require less time, less resources and will create less disturbance in school operation. For a rough guess, this technique could be applied in three-story building with column size 300*300mm with at least four numbers of 16-mm diameter bars. Monolithic shear walls can be situated either along the periphery of the building as shown in figure 5.12 (Appendix-10) or inside the building. Adding walls along the periphery is often easier as it does not upset the school operation. Providing shear walls in one direction will not be problem as almost all partition or cladding walls in transverse direction are solid where as some intervention with opening will be necessary for shear walls in longitudinal direction.
